## R & D STATUS REPORT

10 AUGUST 1981 - 9 FEBRUARY 1982

ARPA Order Number	4140
Customer:	Hughes Research Laboratories
Date of Contract:	9 February 1981
Amount of Contract:	\$108,914.
Contract Number:	N00014-81-C-0286
Principal Investigator:	R. G. Wilson 213/456-6411, Ext. 292
Contract Expiration Date:	30 June 1982
Title:	Ion Implant Damage Regrowth and Characterization

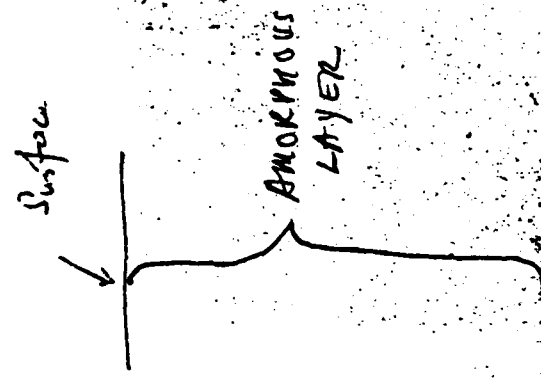
Fig. 3

Figures 1 through 3 show XTEM micrographs for 300 keV Ag implanted in (100) Si before annealing. Figure 1 is for a fluence of  $3 \times 10^{13} \text{ cm}^{-2}$ ; Figure 2 is for  $10^{14} \text{ cm}^{-2}$ ; and Figure 3 is for  $10^{15} \text{ cm}^{-2}$ . The data for  $3 \times 10^{13} \text{ cm}^{-2}$  (Fig. 1) show a damaged but not amorphous graded layer as would be expected for a low fluence implant. The data for  $10^{14} \text{ cm}^{-2}$  are discussed in the next section. The data for  $10^{15} \text{ cm}^{-2}$  (Fig. 3) show a broad amorphous layer extending from the surface to a substantial depth.

300 eV Ag  $\rightarrow$  (111) Si  $\cdot 10^{15} \text{ cm}^{-2}$   
NO ATOMER

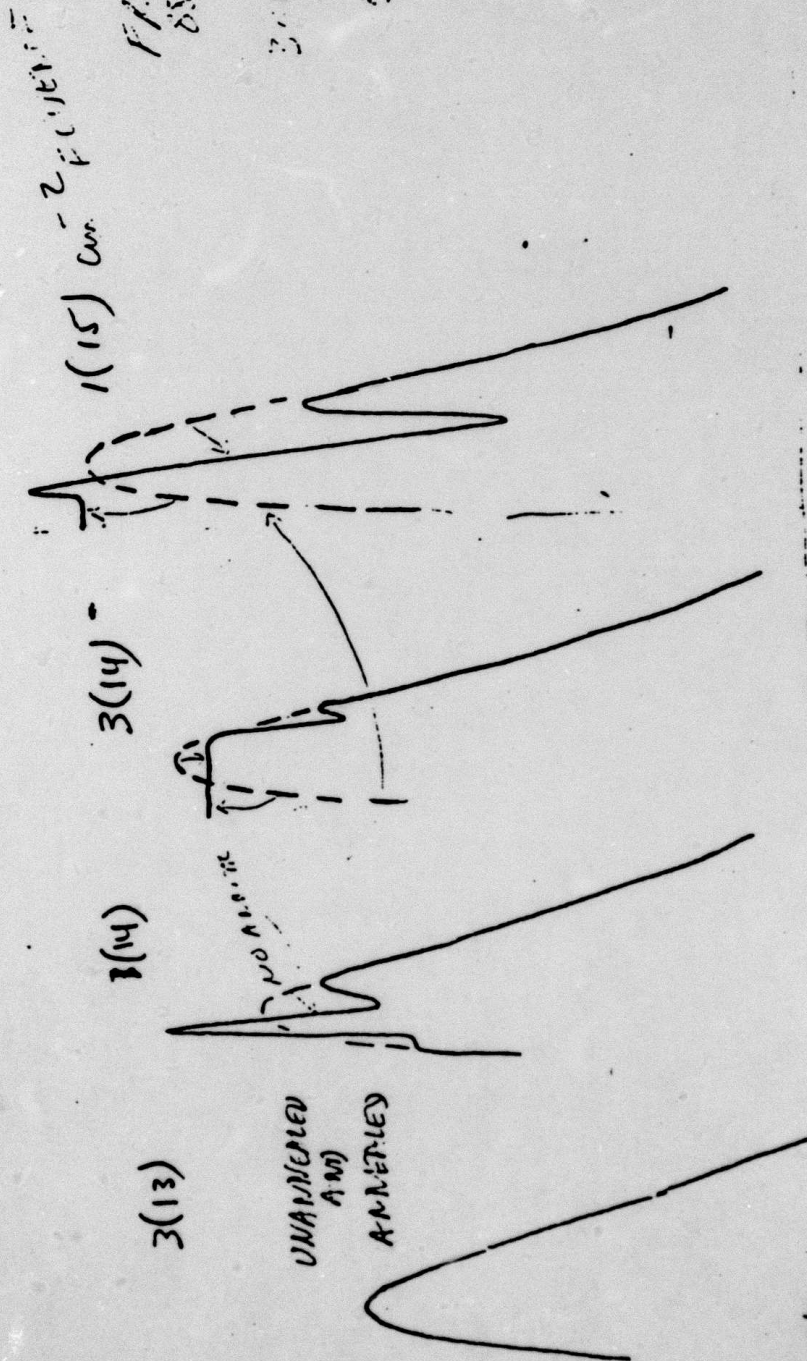
Interpretation of the SIMS profiles of Fig. 8878-209 given in the last report and shown here as Figs. 5 and 6.

Implants: various fluences at 300 keV, (100) Si, annealed at 550°C  
for 20 min

The SIMS profiles given in Figure 8878-209 of the last report are interpreted in light of the XTEM results. All observations except one are consistent with the proposed model. The one discrepancy deserves further study.

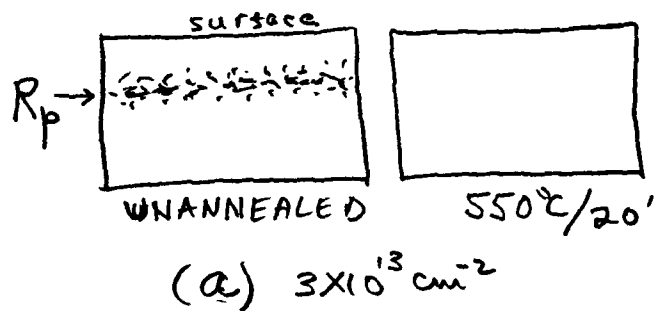
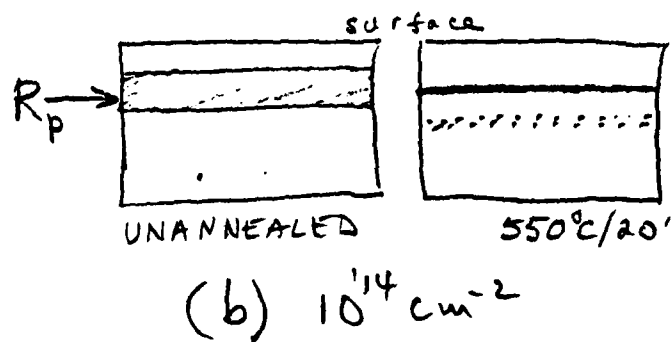
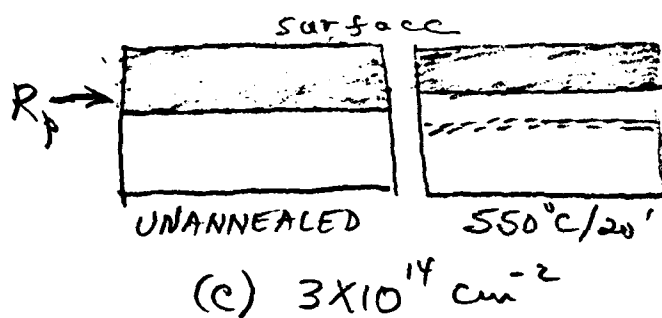
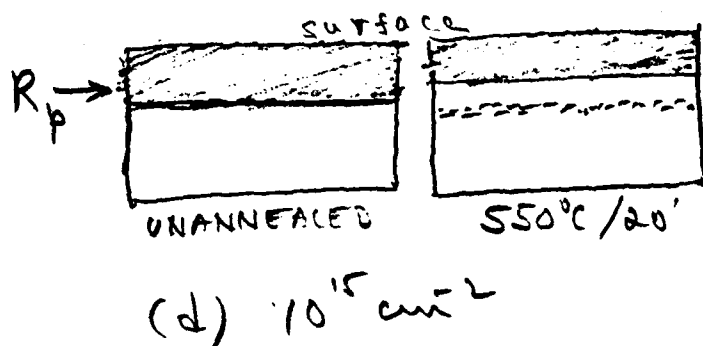
Figure 6: Schematic of the XTEM micrographs interpretation.

The dose in this case was probably too small to create a buried amorphous region. Rather, it created isolated damage clusters (Figure 6a) in the vicinity of  $R_p$ . These clusters annealed out at the  $550^\circ\text{C}$  annealing temperature. Consequently, Ag did not see any discrete defect-rich regions where it could segregate. Diffusion was also minimized because of the low annealing temperature used.

Here the dose used was probably high enough to cause the formation of a buried amorphous layer. Subsequent annealing of this type of structure produces two discrete layers of damage as already observed (see the attached article by Sadana et al.) and is shown schematically in Figure 6b. The shoulder near the surface in the Ag profile is believed to correspond to the vacancy-rich region and the two peaks occur in the vicinity of the two damage layers.

The dose of Ag used here probably produced a continuous amorphous layer that extends to the surface of the sample (Figure 6c). In this type of damage configuration there is only one amorphous/crystalline interface available for regrowth. Comparing the regrowth rate results from this sample with that of the  $10^{14} \text{ cm}^{-2}$  sample at the deeper interface indicates that the regrowth is retarded in the  $3 \times 10^{14} \text{ cm}^{-2}$  sample. The flat region of the profile represents the width of the amorphous layer. A small peak in the deeper region is typical of most implantation and probably correspond to a narrow layer of damage clusters at this depth.

In this case also, the initial damage structure is a continuous amorphous layer extending to the surface (this particular sample has already been studied in the TEM). In principle, the explanation of regrowth of the amorphous layer for the  $3 \times 10^{14} \text{ cm}^{-2}$  sample should also hold here, but apparently there is a contradiction, in that the growth rate of amorphous Si in the  $10^{15} \text{ cm}^{-2}$  sample is accelerated as compared with the  $3 \times 10^{14} \text{ cm}^{-2}$  sample. The first peak correspond to the amorphous/crystalline interface, and the second peak occurs at a damage cluster-rich region as already seen in the TEM measurements.

In conclusion, the 550°C annealing results can be explained by considering a layer of isolated damage clusters, a buried amorphous layer, and a continuous amorphous layer, and by predicting their annealing behavior based on the experience with other ions. However, the results of  $3 \times 10^{14} \text{ cm}^{-2}$  and  $10^{15} \text{ cm}^{-2}$  samples are in disagreement and need further exploration. At higher annealing temperatures, Ag will diffuse into the bulk because of its low solubility in Si. Fairly high concentrations of Ag at 700 and 800°C indicate the formation of some kind of Ag precipitates that seem to break up at 900°C. The reason for the movement of the deeper peak toward the surface is not yet clear.
